Stockton-on-Tees
BOROUGH COUNCIL

Lead Local Flood Authority Flood Investigation Report

Ilkeston Walk, Hardwick, Stockton on Tees

18th May 2013

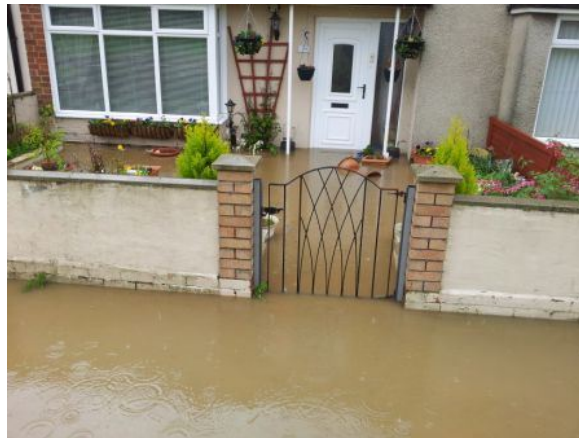
Photograph 1 – A flooded property on Ilkeston Walk.

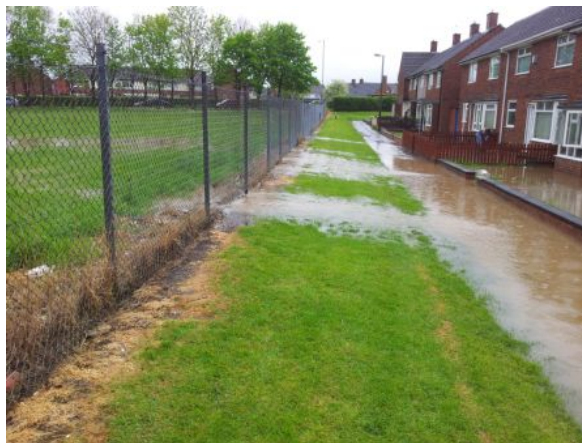
Photograph 2 – Clearly shows the source of flooding as run off from the Arqiva site, the water is collecting at the low point and flooding properties

The field is bounded by a high fence and houses a transmitter. The site is owned by Arqiva, who have been contacted and are unable to supply any details of the land drainage of the site. It is therefore unknown whether or not the site has a positive drainage system.

1. The feasibility of installing additional land drainage to the field is investigated further by Arqiva.
2. The Council submits a bid for funding for property level protection measures.
3. The Council investigates further whether installation of a larger gully would be of any, albeit limited benefit.

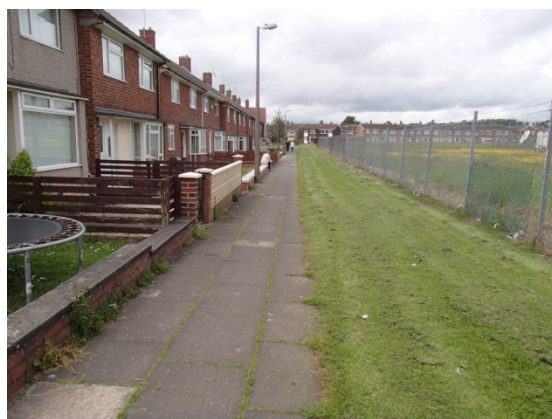
Photograph 3 - Ilkeston Walk < Hardwick –
Photograph taken on site visit – June 2013

The properties on Ilkeston Walk face on to a privately owned field, with an adopted footpath in between. The topography of the site is that the field is at a higher level than the properties and slopes towards them, the footpath is level to the property boundaries, then the front gardens of the properties fall towards the front of the building. The properties are bound by a combination of low walls and fencing. There are access points in the form of gaps or gates. The majority of the properties have large, very low level air bricks which will be the first point of entry of the flood water, followed by the front doors. The properties are a mix of privately owned and social housing (Vela Homes) and do not have any flood protection measures in place.

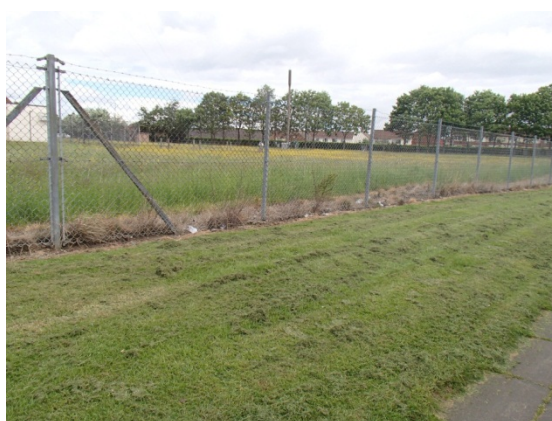
Photograph 4 – Ilkeston Walk, Hardwick, facing North East
towards Arqiva Site
Photograph taken on site visit – June 2013

Anecdotal evidence from residents suggests that the flooding has become worse since some groundwork was carried out in the field on the transmitters. Arqiva have stated that no work has been carried out in the last three years.

The area could benefit from a drainage system being installed the field within the boundary, which would be for the consideration of the fields owners, though any system would need to be sustainable as Northumbrian Water do not allow land drainage to be connected to the sewerage system due to insufficient capacity leading to potential flooding issues elsewhere. Any groundwork undertaken in the field needs to be carefully considered so as not to simply move the flooding problem elsewhere.
