Chapter C02: Bute Street

Conservation Area Appraisal

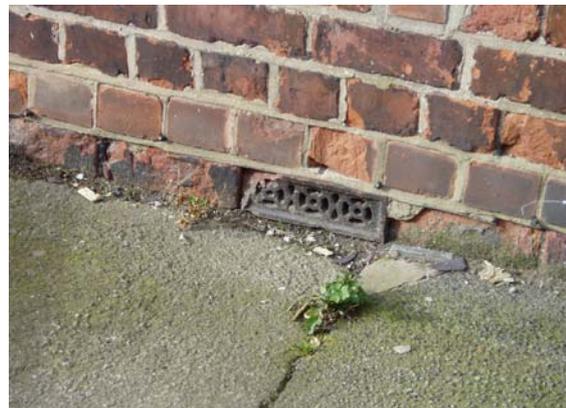
Some repair needed

Nevertheless, the street is in some places becoming tatty and in need of basic maintenance – especially painting of window frames and doors, and some attention to brick pointing and rising damp.

- **Short term**
 - Encourage owners to undertake damp proofing and repairs necessary where damp has caused damage. This will improve the long term existence of Bute Street.
 - Work within the Council to secure the maintenance of the cobbles.
 - Encourage the removal of satellite receiver dishes and a general tidy up of the wires, aerials and other items that currently adorn the fronts of the houses.

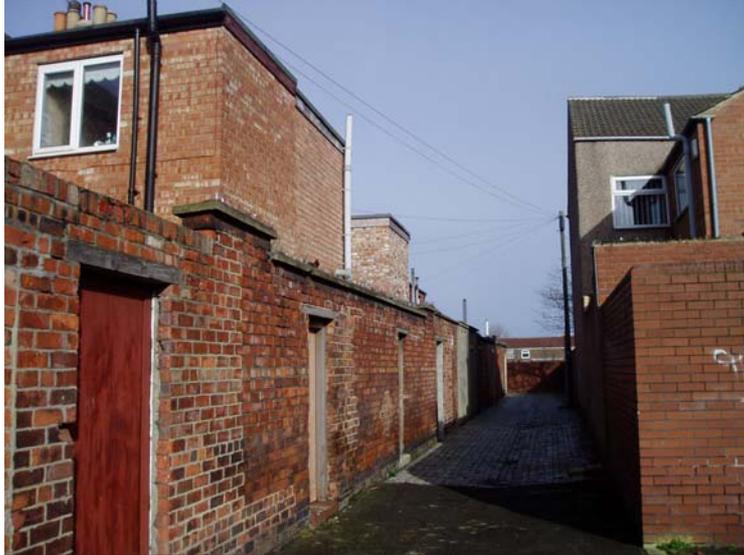
A handful of properties have been extended, and while the extensions themselves appear to be in keeping with the character of the terrace, the rear alleyways have lost their uniformity. This could be rectified in the future when all the dwellings are extended in identical developments, although it is unlikely to occur. It would be unreasonable to remove the existing extensions so it cannot be considered a negative aspect.

Varying rear extensions

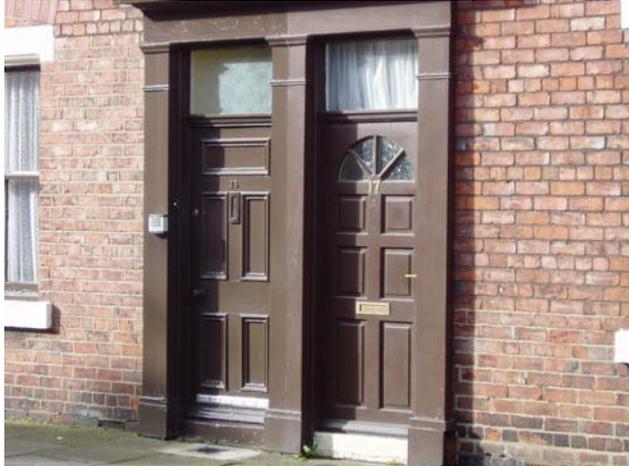
Original colour, but the door on the right is modern and of the wrong design for this period.

mostly in pairs, sharing a small canopy built in to the shape of the surround. Colours currently vary, however a middle brown (matching other timberwork) is the most common colour, and should be restored.

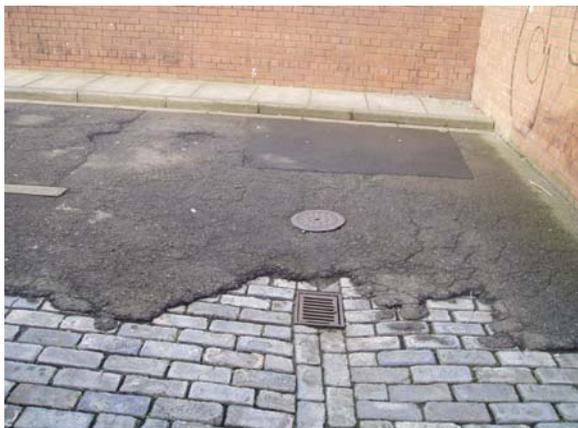
Poor attempt to tarmac the setts

The rear alleyways are paved in the original blue-grey Scoria Blocks, however, like many original surfaces, these have suffered considerably from heavy vehicles and subsidence, but not to the extent that they are impassable.

An attempt to tarmac the setts has been made at some point, however the tarmac is chipping badly and

revealing the setts once more. This is in need of repair to improve the appearance, however it is considered that the complete removal of the tarmac would be more appropriate.

- **Long term**
 - Some larger works are necessary including the removal of tarmac laid over the setts in the rear alleys, and some relaying of the setts where they have failed.
