Chapter C02: Bute Street

Conservation Area Appraisal

General Overview of Bute Street Conservation Area.

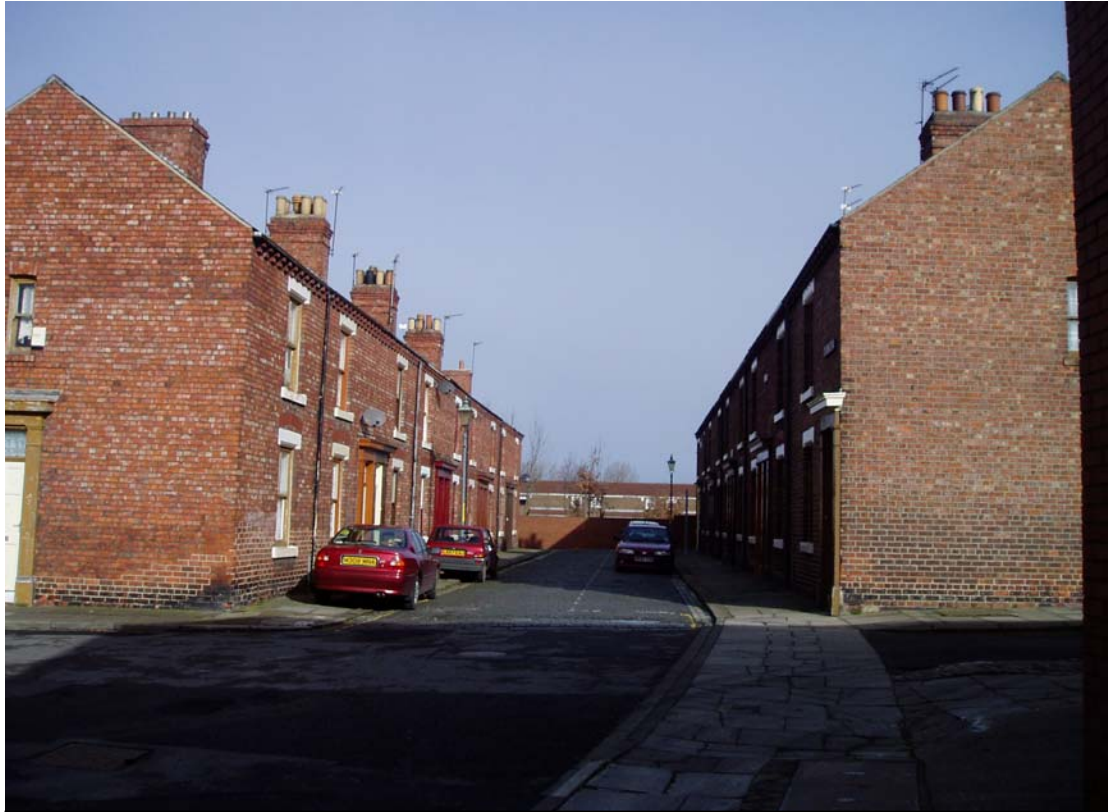
Bute Street : a modest terraced street, but retains much original character

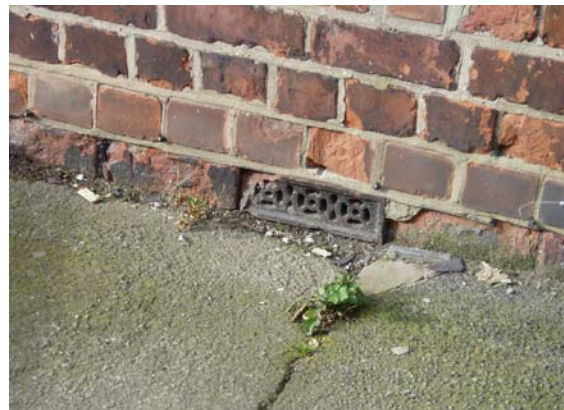
Some repair needed

Nevertheless, the street is in some places becoming tatty and in need of basic maintenance – especially painting of window frames and doors, and some attention to brick pointing and rising damp.

- **Short term**
 - Encourage owners to undertake damp proofing and repairs necessary where damp has caused damage. This will improve the long term existence of Bute Street.
 - Work within the Council to secure the maintenance of the cobbles.
 - Encourage the removal of satellite receiver dishes and a general tidy up of the wires, aerials and other items that currently adorn the fronts of the houses.

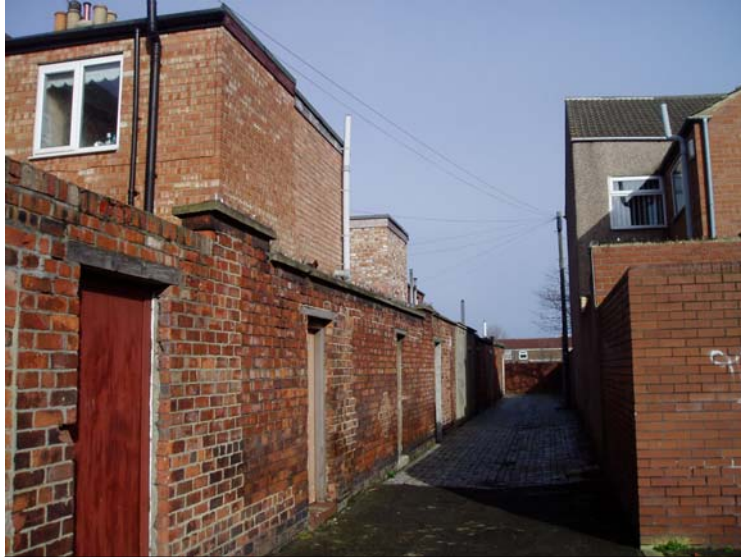
Varying rear extensions

Bute Street sits in a tight gridiron layout, typical of large 19th century terraced housing. The street runs North-South and is closed at the northern end to form a cul-de-sac. The houses open directly onto the footpath at the front, but have a modest linear yard to the rear. Some feature modest extensions of varying design quality.

- **Medium term**
 - Work within the Council to secure the maintenance and repair of the lamp standards.
 - Assist owners in preparing any development proposals to ensure that any new extensions are appropriate and maintain the character of the street.

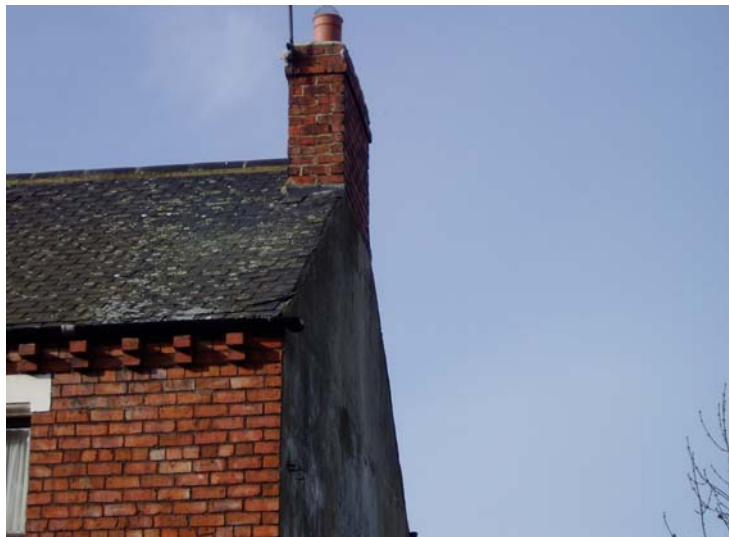
As a terraced street, the roofs are uniform in slate, and continuous, with individual houses marked only by broad brick chimneys with 8 pots. Each end of the terraces features a gable. On rear elevations some flat windows puncture the roofscape where attic conversions have been performed.

Ornate eaves detail and tall chimney

Constructed entirely in a dark reddish-brown local brick, in a simple stretcher bond, the walls are quite plain until the eaves, where an attractive alternating string course is present. This type of detail is not uncommon throughout Teesside, however it may be considered unusual on these otherwise quite unassuming houses.

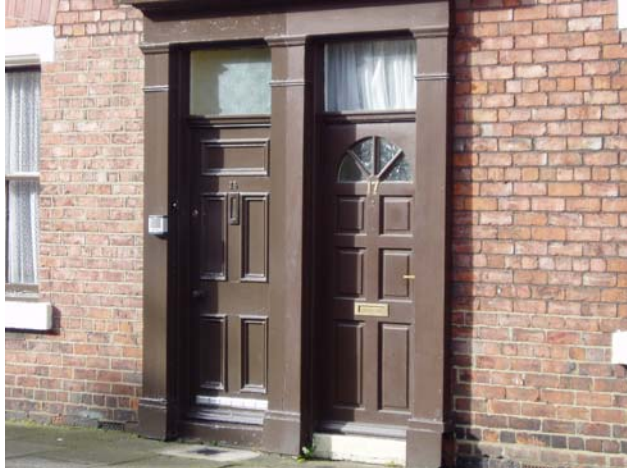
Constructed in timber and featuring either 5 or 6 panels the doors are set in elaborate surrounds with a large fanlight. Doors are

Original colour, but the door on the right is modern and of the wrong design for this period.

mostly in pairs, sharing a small canopy built in to the shape of the surround. Colours currently vary, however a middle brown (matching other timberwork) is the most common colour, and should be restored.

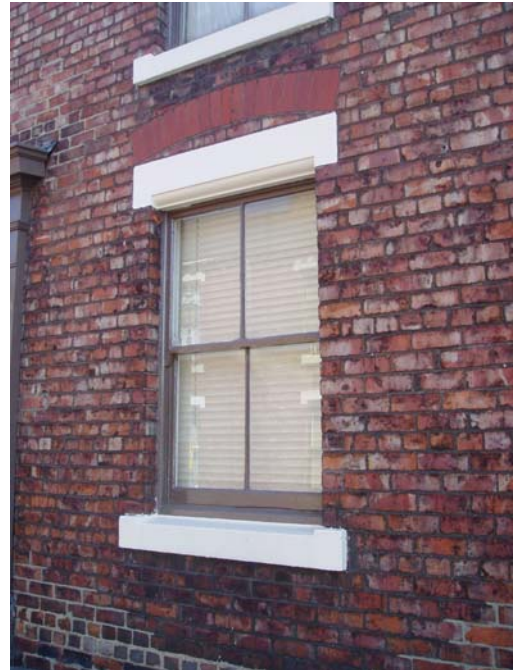
The windows are twice as tall as they are wide, predominantly 2-pane sliding sash, made in narrow timber frames in shades of cream and brown. The windows all feature a stone header and sill, painted in a uniform cream colour. The presence of the stone header is unusual as there is already a curved brick arch above the window. It is assumed that a comprehensive

Typical 4-pane window with arch detail

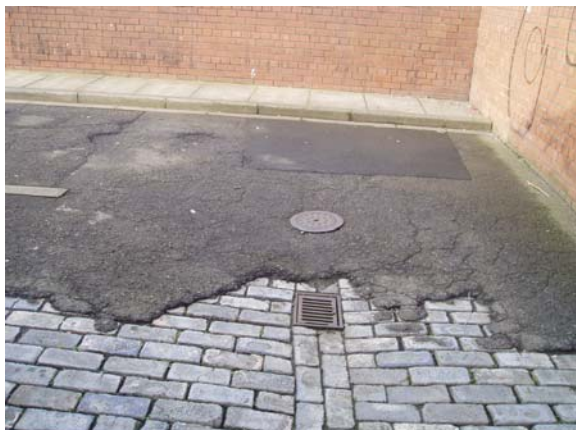
Poor attempt to tarmac the setts

The rear alleyways are paved in the original blue-grey Scoria Blocks, however, like many original surfaces, these have suffered considerably from heavy vehicles and subsidence, but not to the extent that they are impassable.

An attempt to tarmac the setts has been made at some point, however the tarmac is chipping badly and

revealing the setts once more. This is in need of repair to improve the appearance, however it is considered that the complete removal of the tarmac would be more appropriate.

- **Long term**
 - Some larger works are necessary including the removal of tarmac laid over the setts in the rear alleys, and some relaying of the setts where they have failed.
