Stockton-on-Tees
BOROUGH COUNCIL

Lead Local Flood Authority Flood Investigation Report

Ilkeston Walk, Hardwick, Stockton on Tees

18th May 2013

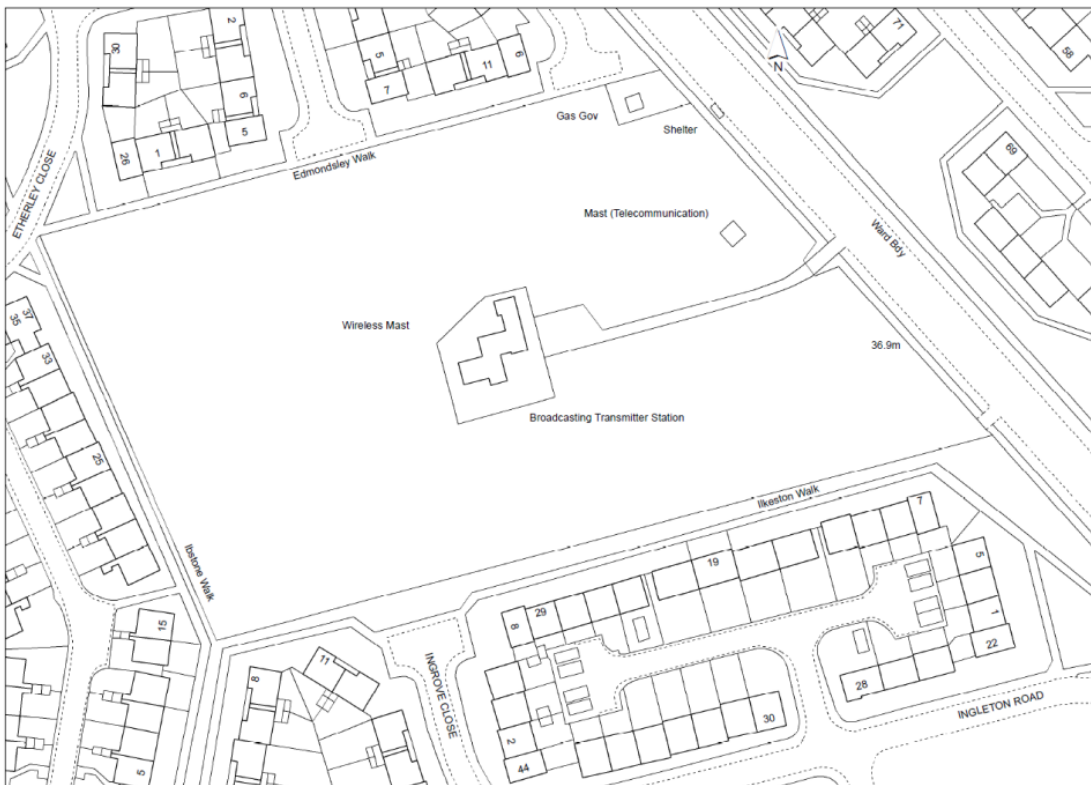
One area severely affected was Ilkeston Walk in the Hardwick area of Stockton on Tees, where up to 9 properties were affected by internal flooding and a further 3 were at risk, causing residents to have to leave their homes.
